Micro-abrasion wear behaviour of TiAlCrSiN nanostructured coatings

R.P. Martinho^a, M.F.C. Andrade, F.J.G. Silva, R.J.D. Alexandre, A.P.M. Baptista

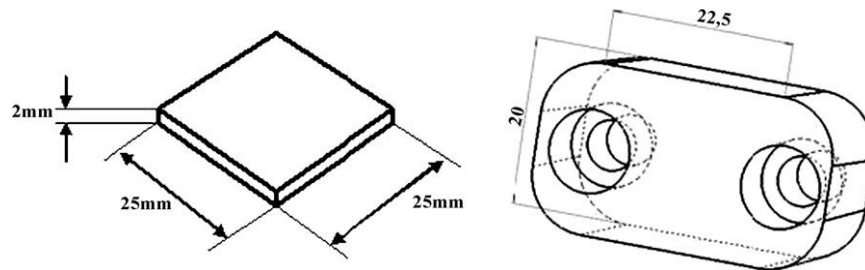
Fig. 1. (a) Laboratorial sample geometry; (b) industrial sample geometry.

In this work, AISI P20 tool steel with 380HBW 2.5/187.5/5 hardness was used as substrate. The laboratorial samples, with a quadrangular shape of 25 mm × 25 mm and 2 mm thickness, were milled and grinded to a mean surface roughness R_a of 0.060 μm in the work surfaces. The industrial samples were machined following the necessary shape and the work surface was also grinded until a same surface roughness had been obtained. Both samples shape are shown in Fig. 1. The chemical composition of this substrate material was confirmed by mass spectroscopy and is given in Table 1.

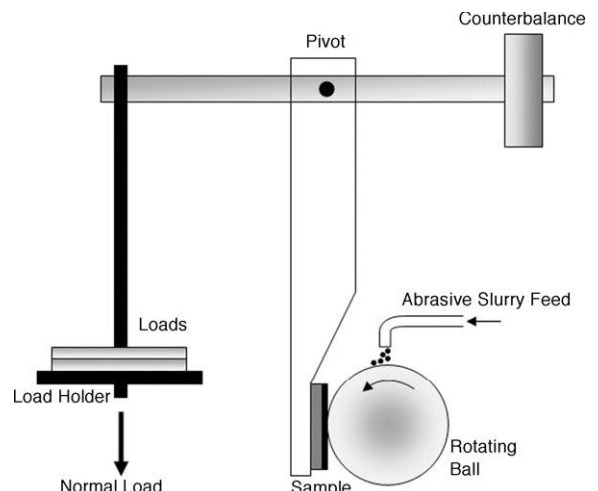
Fig. 2. Schematic diagram of the ball-cratering tribometer used in this work.

In order to quantify the abrasive wear resistance of the TiAlCrSiN film, when compared with the uncoated sample, micro-abrasion tests were performed in a ball-cratering tribometer. A polished ball of AISI 52100 steel of 25 mm diameter was etched in a 10% NITAL solution during 20 s, in order to increase its superficial roughness. In these tests abrasive slurry composed by 35.4 g of SiC F1200 (according to FEPA – Standard 42-2:2006) in 100 ml distilled water was used. The ball rotation speed was 80 rpm (corresponding to 0.105 m s^{-1}) and the normal load, 0.25 N. A schematic diagram of the ball-cratering tribometer used in the laboratorial work is presented in Fig. 2. In order to guarantee the consistence of the results, all tests were made three times with the duration of 200, 500 and 700 cycles (corresponding to 15.71, 39.27 and 54.98 m, respectively), each. At the end of the tests, the micro-abrasion craters were measured and observed by SEM and by optical microscopy (OM) using OLYMPUS BX51M microscope provided with ANALYSIS DOC software and 12.5 Mpixel OLYMPUS digital camera.

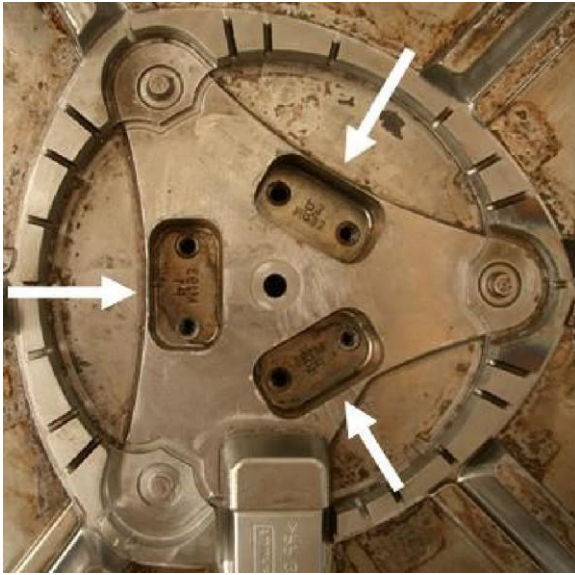
Fig. 3. Mould aspect and insert cavities.

dedicated to produce automotive radiator fans in 30% glass fibre-reinforced polypropylene. This mould, with its cavities, can be observed in Fig. 3. The mould allows obtaining two fans per each injection, in order to increase the productivity. Three inserts were manufactured in order to fit inside the cavities, previously made in the mould. The reinforced polypropylene is injected in the centre of the mould and flow by each feed channel. The local of the inserts was selected in order to obtain the same turbulence conditions of the plastic moisture in the surface, after a quick flow direction shift. 45 000 injections were made, in order to analyze the TiAlCrSiN-coated surface behaviour. In these conditions, it is well-known that AISI P20 tool steel presents an eye-visible abrasive wear, needing a complex maintenance process. Results were carefully analyzed by SEM, in order to identify possible changes and respective wear mechanism compared with the original TiAlCrSiN surface.

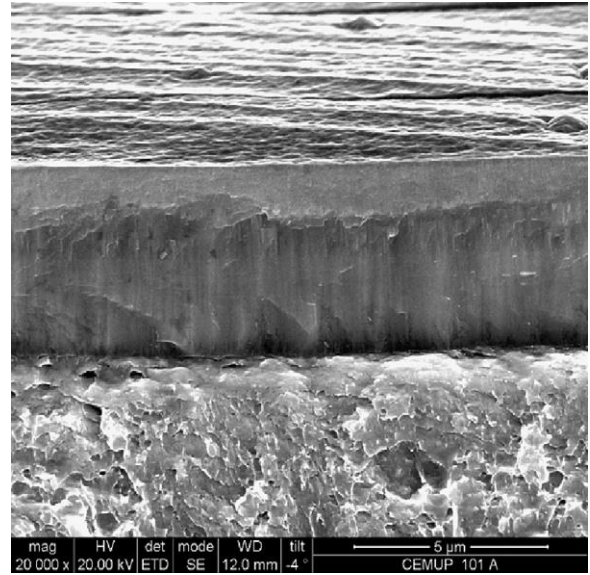
Fig. 4. TiAlCrSiN coating morphological characterization.

After PVD deposition, the film surface was characterized by SEM and AFM. In Fig. 4 it is possible to observe the film morphology with its columnar structure. In the same picture it is possible to observe

two distinct layers: a bottom layer with a columnar structure well-defined and a top layer with a compact structure, corresponding to different PVD deposition phases. These differences are well depicted also in Fig. 5a, obtained in a cross-section view by SEM, after metallographic preparation. Different layers, labelled Z1 and Z2 in Fig. 5a, present small composition differences: the area Z1 is constituted by nano-layers of Al, Ti and Si, when the area Z2 presents only Cr. Chromium nitride is the first layer to deposit. After this, all targets participate in the deposition process. Due to the holder circular motion, samples are exposed to each target in each rotation. Controlling the holder rotation and deposition rate, we can achieve nano-layers with the desired thickness. High magnification Fig. 5b (200 000 \times) allows to observe a multilayered nanostructure with a period of about 65 nm.

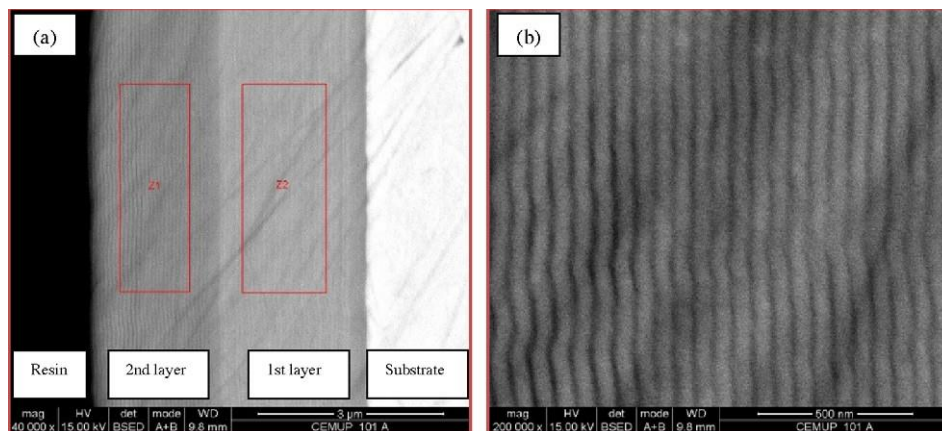
Fig. 5. (a) Cross-section TiAlCrSiN film SEM micrograph after metallographic preparation; (b) Z1 multilayered nanostructure view.

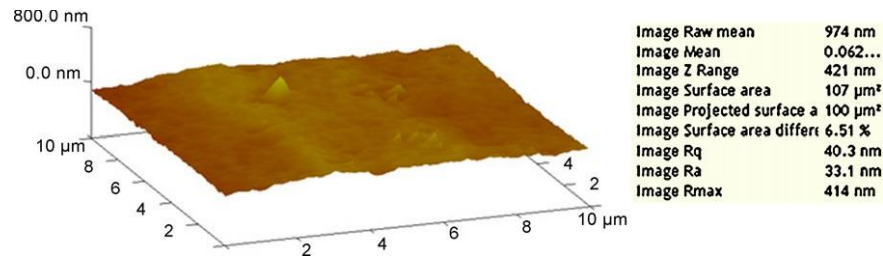
Fig. 6. TiAlCrSiN film surface AFM analysis.

The topography and roughness of the TiAlCrSiN film were accessed by AFM with two different analysis areas: 10 $\mu\text{m} \times 10 \mu\text{m}$ and 50 $\mu\text{m} \times 50 \mu\text{m}$. The mean average roughness (R_a) measured on the film was 0.033 μm (0.128 μm in the substrate surface) and the maximum roughness height (R_{max}) was 0.414 μm (2.067 μm in the substrate surface) according to DIN 4768. As can be observed, the roughness parameter values decreased after PVD film deposition, which corresponds to a preferable physical deposition on the substrate valleys. Despite of this, some film peaks can be seen in the

AFM scan depicted in Fig. 6. These peaks correspond to aggregates grew in the surface during the PVD deposition process, due to thermodynamic favourable conditions. This phenomenon was already largely discussed in the literature [9,13] and it is common in PVD industrial processes.

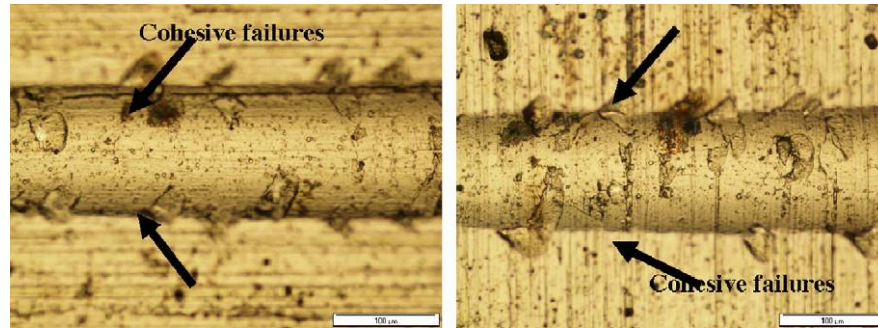
Fig. 7. TiAlCrSiN film cohesive failure in longitudinal and transversal directions.

by the grinding process), following the test parameters described in Section 2. At the end of the tests, the scratch grooves were carefully observed by optical microscopy. Cohesive failures result of film internal failure mechanisms and the substrate was not visible. In this case, no interface troubles are usually observed. Adhesive failures acting in the film/substrate interface provoke film detachment. The critical load Lc_1 , corresponding to cohesive failure, measured in longitudinal and transversal directions were 18 and 16 N, respectively, and the critical load Lc_2 , corresponding to adhesive failure, measured in the same directions were 39 and 25 N, respectively. The difference between Lc_1 and Lc_2 values must be due to the grinding marks. Cohesive and adhesive failures can be observed in Figs. 7 and 8, respectively. These values are in line with other analysis made in similar films, but are lower than the expectations. This can be due by the high hardness of the film, thin thickness and/or surface roughness. Nevertheless, micro-abrasion crater borders showed a very good adhesion between the film and substrate because no spallation was observed in the crater exit border grooves.

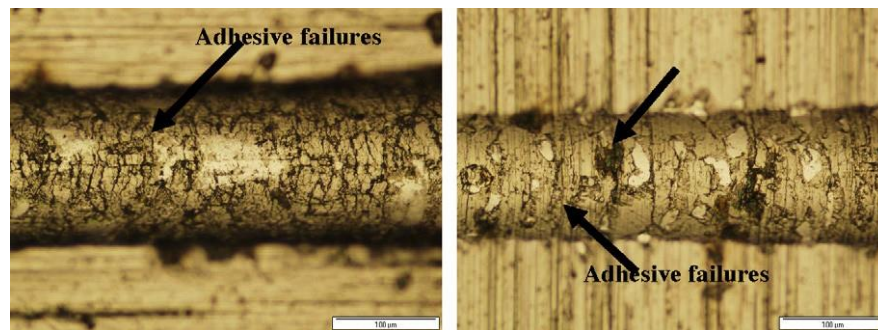
Fig. 8. TiAlCrSiN film adhesive failure in longitudinal and transversal directions.

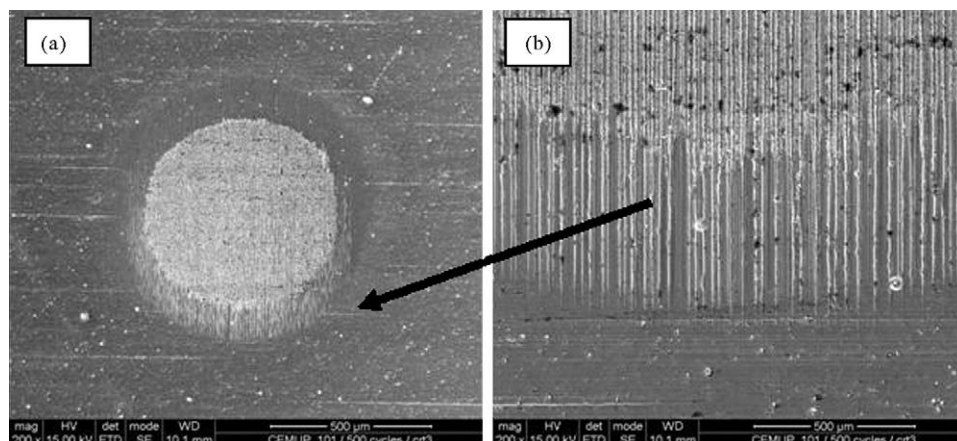
Fig. 9. (a) SEM micrograph of micro-abrasion crater after 500 cycles; (b) abrasion grooves.

Micro-abrasion tests were carried out according to the conditions mentioned in Section 2. All the craters present well-defined circular shape. After 200 cycles (corresponding to 15.71 m), no film perforation was observed. Nevertheless, tests with 500 cycles show coating perforation as can be seen in Fig. 9a.

Summary results of micro-abrasion tests can be observed in Table 2. Each crater diameter was measured in two orthogonal directions, in order to minimize error measurements due to crater circular distortion. The results presented correspond to three tests average, made according each test conditions. Observing Fig. 9b, regular-spaced parallel grooves, corresponding to the

crater side where abrasive slurry left the contact, denoting that a two-body wear mechanism was present can be seen. Basically, it is possible to observe that the wear resistance was drastically improved by the TiAlCrSiN coating. This can be observed attending the trend lines drew on the graphic of Fig. 10a where the line slope for TiAlCrSiN-coated substrate present a large benefit when compared with uncoated substrate. Three wear coefficients were calculated: substrate, coating and global. Calculations were made according to the integrated form [14] of an equation originally proposed by Kassman et al. [15]. The wear coefficient increases consistently for TiAlCrSiN-coated samples, due to film perforation, when remains quasi-constant for the uncoated samples (Fig. 10b).

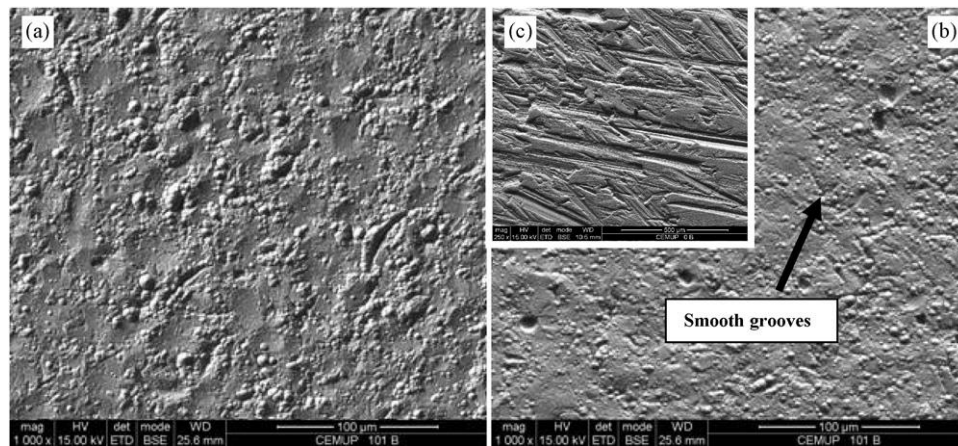
Fig. 11. (a) Original TiAlCrSiN-coated surface (1000 \times); (b) moulding TiAlCrSiN-coated surface after 45 000 cycles of the injection of 30% glass fibre-reinforced polypropylene (1000 \times); (c) uncoated steel moulding surface after 45 000 cycles of the injection of 30% glass fibre-reinforced polypropylene (250 \times).

In order to test the same coating in industrial environment, coated inserts were mounted in the mould, as described before. In Fig. 11a it is possible to compare the original coated surface (a), with the smooth worn-coated surface (b). After 45 000 injections with 30% glass fibers-reinforced polypropylene, only very small and rare scars and also random smooth grooves (ill-defined) were observed in the coated surface due to glass fibers tips during injection process. A light surface smoothness was also observed, resulting in some aggregate polishing process. No film aggregates detachment was registered. In the same Fig. 11c a steel AISI P20 worn surface subject to the same work can be observed.
