# Experimental and numerical evaluation of composite repairs on wood beams damaged by cross-graining

R.D.S.G. Campilho, M.F.S.F. de Moura, A.M.J.P. Barreto, J.J.L. Morais, J.J.M.S. Domingues

An experimental and Finite Element study was performed on the bending behaviour of wood beams of the *Pinus Pinaster* species repaired with adhesively-bonded carbon-epoxy patches, after sustaining damage by cross-grain failure. This damage is characterized by crack growth at a small angle to the beams longitudinal axis, due to misalignment between the wood fibres and the beam axis. Cross-grain failure can occur in large-scale in a wood member when trees that have grown spirally or with a pronounced taper are cut for lumber. Three patch lengths were tested. The simulations include the possibility of cohesive fracture of the adhesive layer, failure within the wood beam in two propagation planes and patch interlaminar failure, by the use of cohesive zone modelling. The respective cohesive properties were estimated either by an inverse method or from the literature. The comparison with the tests allowed the validation of the proposed methodology, opening a good perspective for the reduction of co

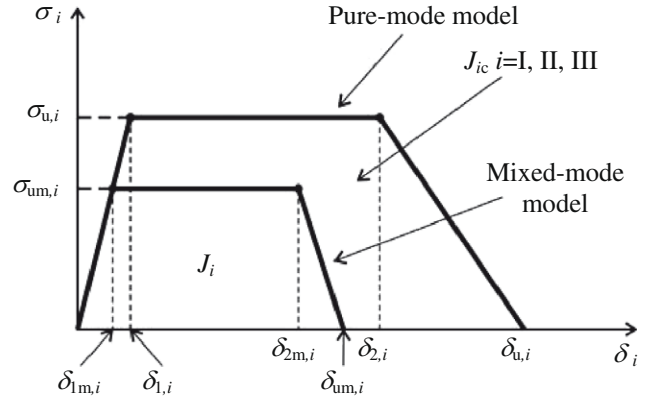
Fig. 1. The trapezoidal softening law for pure-mode and mixed-mode.

A mixed-mode (I + II) CZM implemented within interface finite elements was used to simulate an adhesive layer of Araldite® 2015 with thickness ( $t_A$ ) of 0.2 mm. A trapezoidal law between stresses ( $\sigma$ ) and relative displacements ( $\delta_r$ ) between homologous points of the interface elements with zero thickness was considered (Fig. 1), to account for the adhesive ductility [25–27]. The homologous points correspond to the initially superimposed points of the interface elements in the numerical model, which are connected by the mixed-mode CZM of Fig. 1. The trapezoidal law was also used with some modifications to simulate the wood and patch fractures.

The presented mixed-mode CZM was used to simulate a  $t_A = 0.2$  mm layer of Araldite® 2015. The adhesive layer elastic stiffness in tension and shear (up to  $\delta_{1,i}$ , Fig. 1) is defined from the experimentally measured values of Young's modulus ( $E = 1850$  MPa) and shear modulus ( $G = 650$  MPa) [29], as detailed in the work of Campilho et al. [28]. In the present work, the cohesive laws of the adhesive layer in pure modes I and II were estimated by Double Cantilever Beam (DCB) (mode I) and End-Notched Flexure (ENF) (mode II) tests using an inverse data fitting procedure [30–32]. This course of action is supported by the typically varying mechanical properties of adhesive layers with  $t_A$ , diverging also to the adhesive bulk properties [25]. This is due to the influence of the surrounding adherends on the height and extension of the Fracture Process Zone (FPZ). Actually, in adhesive layers, the FPZ height is naturally confined by  $t_A$ , but its length extends much longer ahead of the

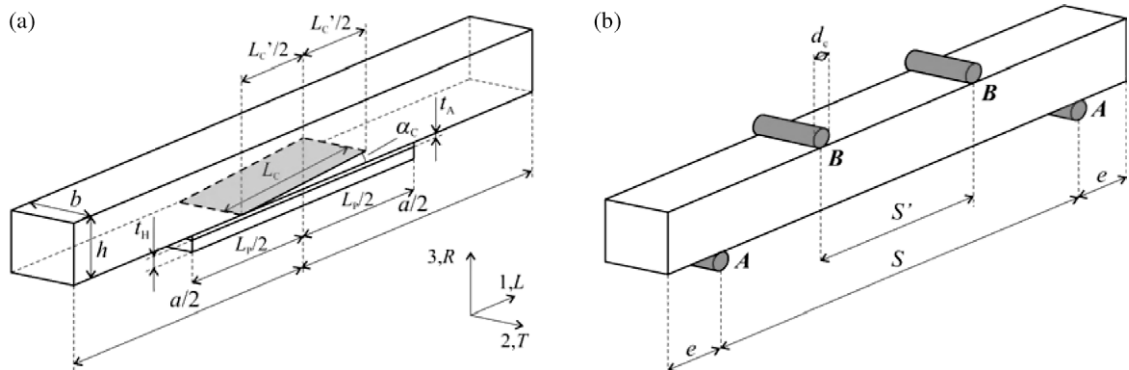
**Fig. 2.** Schematic representation of the repair with the characteristic dimensions (a) and test setup (b).

crack tip than in bulk adhesives. [25–27]. Failure within the wood (Fig. 2) in the *RL* plane (horizontal longitudinal plane of the beam) and in the *LR* plane (cross-sectional plane of the beam) is also considered in the FE models, to simulate the experimental fracture events. The cohesive parameters for an *RL* fracture were established from previous works [33,34]. The *LR* parameters were estimated from typical values for this wood species. For the wood and patch cohesive laws, triangular laws were considered ( $\delta_{2,i} = \delta_{1,i}$  in Fig. 1), due to the absence of plasticity in these materials, and a penalty function method was used until  $\sigma_{u,i}$  (Fig. 1). Table 1 details the cohesive parameters for the different fractures [33–35].

Fig. 2 specifies the geometry and test setup of the repairs. The analysis also comprises the undamaged and unrepaired (cracked) beams, for an optimization study. The proposed repair consists on adhesively-bonding a CFRP patch in the face under tension to strengthen the cracked region of the beam. The characteristic dimensions are the beam length ( $a = 300$  mm), width ( $b = 20$  mm) and height ( $h = 20$  mm), crack length projection along the *L* direction ( $L_c = 20$  mm), cross-grain angle ( $\alpha_c = 15^\circ$ ), patch thickness ( $t_H = 0.6$  mm),  $t_A = 0.2$  mm, and  $L_p = 40, 60$  and  $80$  mm. It should be emphasized that scaled repair geometries of small dimensions were used to provide design principles for the proposed repair solution and to validate the proposed numerical methodology. It is not guaranteed that the scaled specimens strength is in exact proportion to the dimensions of an identical large-scale repair, especially due to a typical larger number of defects in large-scale wood trunks, scale effects in layered composite materials [36], and also accounting for the different behaviour of adhesive layers depending on their thickness constraints [37]. The 4 PB test setup assures a constant bending moment at the repaired central region of the beam ( $S = 260$  mm,  $S' = 130$  mm,  $d_c = 10$  mm,  $e = 20$  mm). **A** and **B** represent the supporting and loading cylinders, respectively. Since the patch will experience uniaxial tension, it consists on a unidirectional lay-up with the fibres aligned along the beam length [38]. The axes 1–3 of Fig. 2 correspond to the fibre, transverse and thickness directions of the CFRP patch, respectively. The *R*, *L*, *T* coordinate system pertains to the wood orientations (fibres longitudinal direction (*L*), rings radial direction (*R*) and rings tangential direction (*T*)). Conditioning of the wood beams prior to fabrication of the repairs and testing consisted on leaving the wood specimens in a dry environment for at least 1 month, to be completely consistent with the characterization of elastic properties performed in references [33,34]. Considering the specimens fabrication, particular attention should be paid to the cross-grain crack. A vertical saw equipment with a 1 mm thickness High-Speed Steel saw was used to this end, yielding an approximately 1 mm gap between the crack faces, which was also considered in the FE simulations. For a precise cut a guiding system was used, comprising a ruler parallel to the saw and a  $15^\circ$  wedge. A sharp crack tip was afterwards produced with a 0.1 mm thickness razor blade. This blade, which was initially centred in the 1 mm crack gap using calibrated steel bars, was used to extend the crack up to the value of  $L_c$ , measured with a digital calliper. The patches were fabricated using CFRP prepreg (Texipreg HS 160 RM from SEAL®) with 0.15 mm of ply thickness. The value of  $t_H$  was selected numerically before the experiments as the minimum value not to exceed the CFRP strength in the fibres direction. The wood and patch surfaces to be bonded were previously abraded and cleaned with compressed air (wood) or acetone (CFRP patch). The ductile adhesive Araldite® 2015 was used to bond the patches, being employed 0.2 mm diameter nylon fishing lines as stoppers near the patch edges to produce the desired value of  $t_A$ , and a manual patch positioning method with a digital calliper for a correct alignment. The specimens were cured at room temperature. The tests were carried

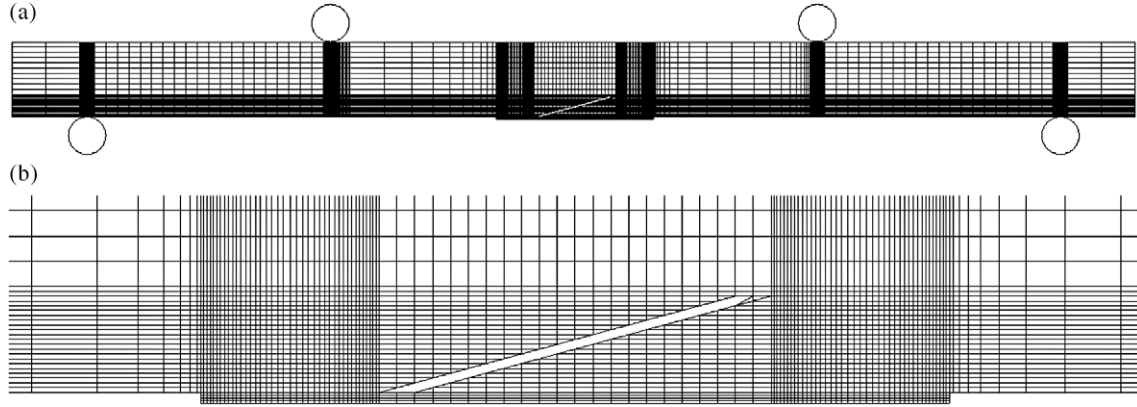
Fig. 3. Mesh for the  $L_p = 40$  mm repair (a) and detail at the repaired region (b).

The FE simulations were performed in ABAQUS®, considering geometrical non-linearities. The wood and CFRP patches were modelled as elastic orthotropic materials, with the following properties: wood ( $E_L = 10.2$  GPa,  $E_R = E_T = 1010$  MPa,  $\nu_{LR} = \nu_{LT} = 0.342$ ,  $\nu_{RT} = 0.380$ ,  $G_{LR} = 1120$  MPa,  $G_{LT} = 1040$  MPa,  $G_{RT} = 170$  MPa; [33,34]) and CFRP ( $E_1 = 109$  GPa,  $E_2 = E_3 = 8819$  MPa,  $\nu_{12} = \nu_{13} = 0.342$ ,  $\nu_{23} = 0.380$ ,  $G_{12} = G_{13} = 4315$  MPa,  $G_{23} = 3200$  MPa [39]). These properties were obtained either performing specific tests or taking advantage of the available relations for orthotropic elasticity. More specifically, the most important properties for the outcome of the simulations (such as  $E_L$  and  $\nu_{LR}$  for the wood beam or  $E_1$  and  $\nu_{12}$  for the CFRP patch) were always obtained from experimental tests. Apart from this fact, and since there is a significant stiffness variation of wood between specimens of the same species, the reference value of  $E_L$  had to be tuned to the experimental *P*– $\delta$  curves, giving 10.2 GPa as the value that most accurately represented the experiments. The FE mesh was built with plane-stress 8-node rectangular and 6-node triangular solid elements. Fig. 3 relates to the  $L_p = 40$  mm repair (a) and respective detail at the damaged region (b). Near the cylinders, 60 elements were employed over a length of 4 mm for a smooth sliding under load. In the repairs height, two mesh sizes were applied: a more refined mesh at the tensile region comprising the cross-grain crack, with 22 elements, and a coarser mesh with ten elements at the compression region. In the beams length, the mesh is moderately refined along the extent of the crack, since this region is not expected to be severely loaded. The bonded regions at both sides of the crack were simulated with forty elements, with bias effects for an accurate

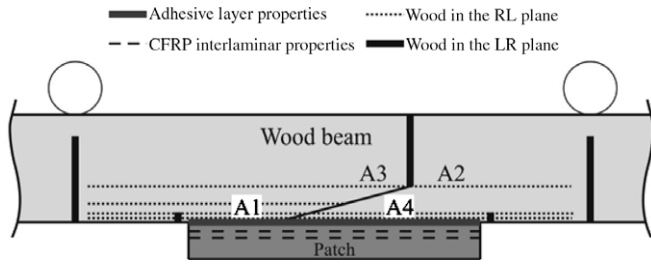
Fig. 4. Placement of the interface elements with different cohesive laws in the numerical models.

characterization of the expected peak stresses near the patch edges [39,40]. The patch was modelled with four solid elements through thickness. Fig. 4 shows the cohesive elements loci to simulate different fractures. The adhesive layer was simulated with the trapezoidal cohesive laws. The possibility of a patch interlaminar failure was equated at 0.15 and 0.30 mm of the adhesive/patch interface. Within the wood beam, the mesh was set to include cohesive elements horizontally to simulate *RL* failures. The experiments allowed the establishment of the limit distances between these planes and the adhesive/patch interface, defined at 0.3 and 0.6 mm. In Fig. 4, failure paths A1 and A4 correspond to damage propagation near the smaller and larger bonds, respectively, either in the patch, adhesive or wood beam. *RL* damage propagations were also considered initiating at the crack tip and growing up to the rightmost (path A2) and leftmost (path A3) loading cylinder, and initiating at the middle of the cross-grain crack height up to the leftmost loading cylinder. *LR* failures were equated below the loading cylinders and initiating at the crack tip. The propagation of the cross-grain crack with its initial orientation was not addressed, since this would pertain to a very specific set of conditions that are not satisfied in most fabricated repairs. In fact, these present the wood fibres almost perfectly aligned in the *L* direction and, under these conditions, the induced cross-grain crack is expected to propagate either in the *RL* or *LR* planes.

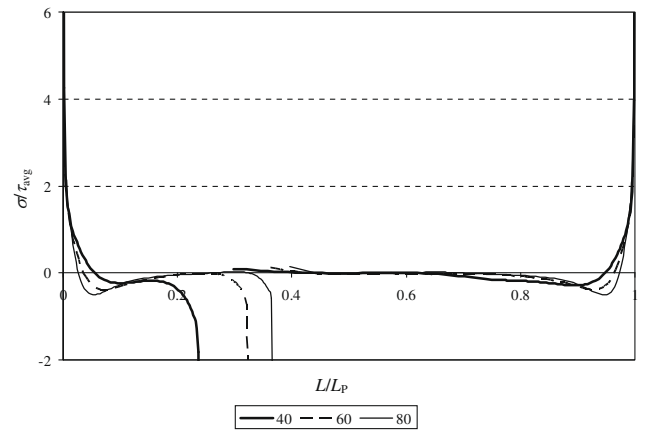
Fig. 5. Normalized  $\sigma$  stress distributions in the adhesive layer as a function of  $L_p$ .

Evaluation of the repairs initiates with an elastic stress analysis in the adhesive layer, considering through-thickness normal stresses ( $\sigma$ ; Fig. 5) and shear stresses in the *RL* plane of the beam ( $\tau$ ; Fig. 6). The main tendencies reported in this study can be extended to the neighbouring horizontal planes in the patch and wood,

despite some expected variations in the peak values [41].  $\sigma$  and  $\tau$  stresses are normalized by  $\tau_{avg}$ , the average shear stress along  $L_p$  for each one of the repairs.  $L/L_p$  represents the patch normalized distance from the patch edge.  $\sigma$  stresses are approximately nil, excluding at the patch edges, where  $\sigma$  peel stresses peak, and at the crack gap, which shows a compressive singularity.  $\sigma$  stresses are usually significantly smaller in magnitude than  $\tau$  stresses along the bond length.  $\tau$  stresses peak near the patch edges, gradually increasing up to those regions. The bond regions outside the wood spike (approximately  $0 < L/L_p < 0.25$  and  $0.75 < L/L_p < 1$ ) assure the

load transfer at the tension regions, leaving the weakened wood spike region practically unloaded. With the increase of  $L_p$ ,  $\sigma$  compressive stresses diminish at the bond gap and increase near the patch edges. The smallest value of  $L_p$  yields significantly higher magnitude  $\tau$  stresses at the smaller bond overloading this region, which may cause a premature failure. Increasing  $L_p$  gradually cancels this effect, as  $\tau$  stresses level between the two bonds. This analysis points to an increase of the maximum load ( $P_m$ ) with  $L_p$ , based on the increase of the shear area available to deviate loads from the cracked region to the sane portions of the beam, and due to the levelling of  $\tau$  stresses between the two bonds.

failures in the wood at path A1 at 0.3 mm of the adhesive layer and at path A2. At this instant,  $P_m$  dropped abruptly while the crack at path A2 continued to grow. Fracture at path A1 is related to the smaller length of this bond, causing higher stresses than at the opposite bond (Figs. 5 and 6). This is more evident for the smallest value of  $L_p$ . Subsequently, the repair failed abruptly at path A3 (event LP2). It must be mentioned that, at the time of the initial wood failure at path A1, most of the adhesive layer cohesive elements were already in the softening stage ( $\delta_i > \delta_{1m,i}$  in Fig. 1), implying that small variations in the repair constituents properties could result on a cohesive failure of the adhesive layer. The  $L_p = 60$  and 80 mm (Fig. 7d) repairs failed concurrently at paths A1 (in the wood at 0.3 mm of the adhesive layer), A2 and A3.

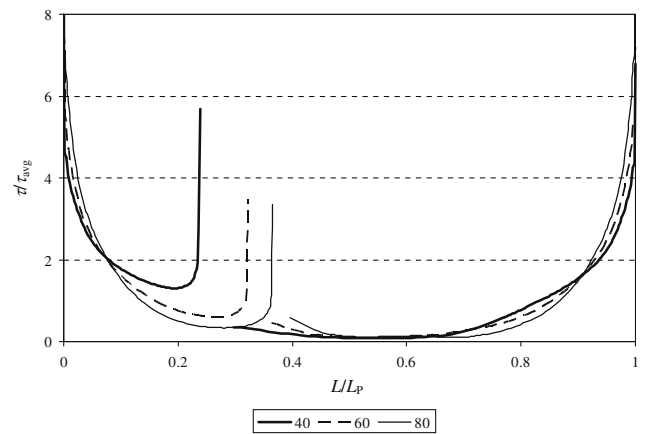
Fig. 6. Normalized  $\tau$  stress distributions in the adhesive layer as a function of  $L_p$ .

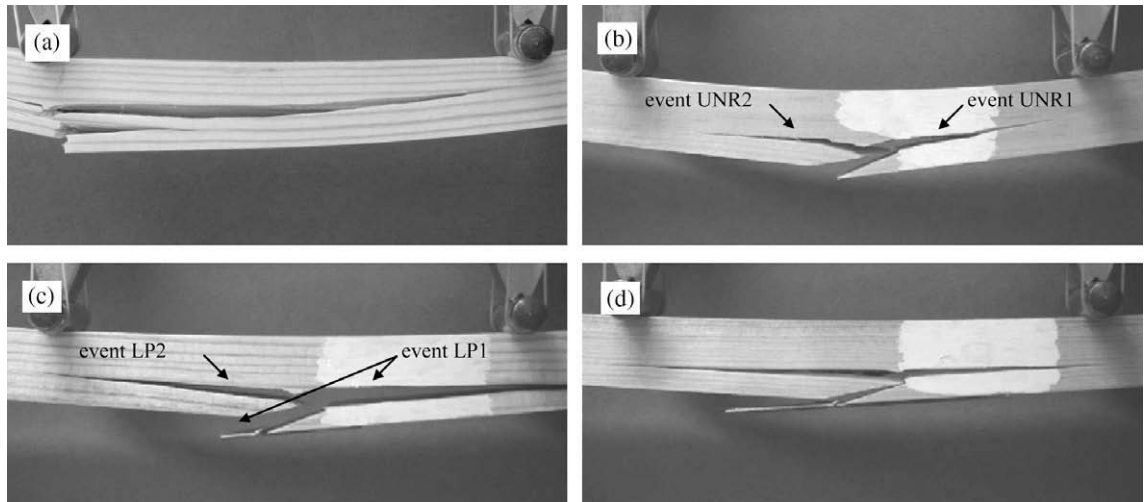
**Fig. 8.** Experimental failures: vertically in the *LR* plane below the loading cylinder for an undamaged beam (a), along paths A2 and A3 for an unrepaired beam (b), and along paths A1, A2 and A3 for the  $L_p = 40$  mm (c) and  $L_p = 80$  mm (d) repairs.

The experimental damage events are described in this section. The undamaged wood beam attained experimentally  $P_m$  by a pure tension *LR* fracture below the loading cylinders (Fig. 8a). *RL* crack propagation followed under residual loads. For the unrepaired beams, damage initiated by a *RL* propagation along path A2 (event UNR1), causing only a reduction of stiffness. Damage continued to grow steadily up to  $P_m$ , occurring due to *RL* fractures at paths A2 and A3 (Fig. 8b), instantaneously up to near the loading cylinders (event UNR2). In the  $L_p = 40$  mm repairs, damage initiated with simultaneous *RL* failures at paths A1 (in the wood at 0.3 mm of the adhesive layer) and A2, causing a drop of  $P_m$  (event LP1). After-

wards, a *RL* failure at path A3 occurred (event LP2; Fig. 8c). The observed fracture at path A1 within the wood beam denotes a weaker strength compared to the adhesive layer and respective interfaces. Failure in the  $L_p = 60$  and 80 mm (Fig. 8d) repairs occurred simultaneous at paths A1 (in the wood at 0.3 mm of the adhesive layer), A2 and A3. Up to  $P_m$ , no evidence of damage was found. Fracture at paths A1, A2 and A3 always occurred concurrently, owing to the bigger values of  $P_m$  than for the previous repair, caused by a larger shear resistant area.

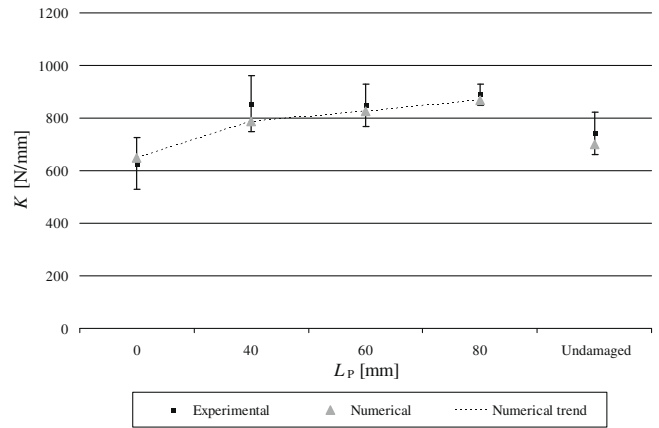
Fig. 11.  $K$  as a function of  $L_p$ . Experimental results, numerical predictions and respective tendency as a function of  $L_p$ .

Figs. 11 and 12 evaluate the experimental and FE results, in terms of elastic stiffness ( $K$ ) and  $P_m$ , respectively, as functions of

$L_p$  ( $L_p = 0$  mm corresponds to the unrepaired beam).  $K$  is defined as the  $P/\delta$  quotient in the initial part of the  $P$ - $\delta$  curve. The FE predictions of  $K$  were in close agreement with the tests, although in most cases the average experimental values of  $K$  were slightly underpredicted. The increasing tendency of  $K$  with  $L_p$  can be explained by the corresponding increase of the adhesive shear area [19]. The correlations between the experimental and the FE values of  $P_m$  were also accurate. The cross-graining crack led to a drop on  $P_m$  of slightly more than 50%. Repairing resulted on an approximately proportional increase of  $P_m$  with  $L_p$ , although at a decreasing rate. Given that in these repairs  $P_m$  is governed by wood failure at path A1, it can be concluded that the increasing magnitude of  $\sigma$  and  $\tau$  peak stresses with  $L_p$  at the patch edge at  $x/L_p = 1$  is responsible for this non-proportional behaviour with  $L_p$ . Figs. 5 and 6, although not relating to stresses within the wood, exemplify this tendency. The  $L_p = 80$  mm repair allows the re-establishment of the undamaged beam strength. The slightly smaller FE value of  $P_m$  justifies the numerical failure at the repaired region (Fig. 7d), rather than vertically below the loading cylinders. However, immediately before fracture, this failure mechanism was imminent, and would occur if  $P_m$  reached the undamaged beam value (which failed vertically below the loading cylinders).

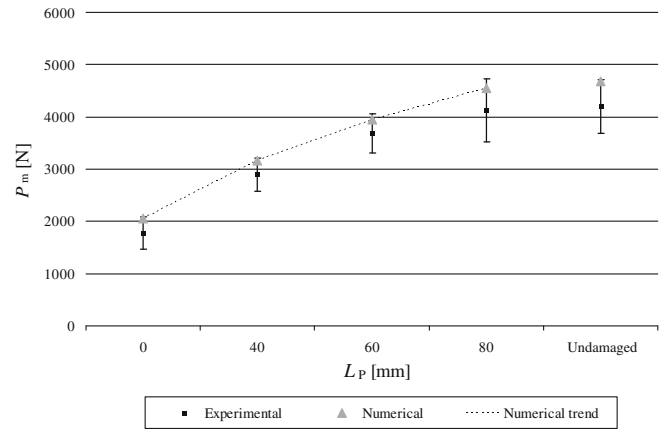
Fig. 12.  $P_m$  as a function of  $L_p$ . Experimental results, numerical predictions and respective tendency as a function of  $L_p$ .

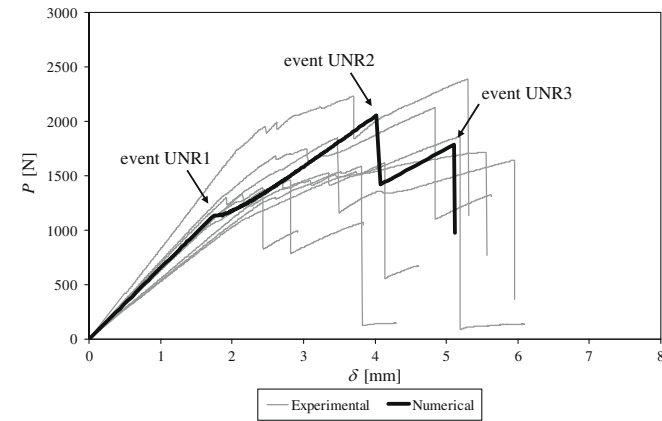
Fig. 9. Experimental and numerical  $P$ - $\delta$  curves for the unrepaired beam.

Figs. 9 and 10 compare the experimental and numerical  $P$ - $\delta$  curves for two of the tested conditions. The unrepaired beam (Fig. 9) revealed numerically a drop of  $P$  owing to damage initiation at the tip of the cross-graining crack, which is clearly visible at  $\delta \approx 1.8$  mm and is within the range of the experiments (event UNR1). The numerical value of  $P_m$ , caused by an abrupt *RL* failure at path A3 (event UNR2), overpredicted the experiments for most of the specimens. After the drop of  $P_m$ ,  $P$  increased up to complete failure, by tension above the cross-grain crack tip (event UNR3). Fig. 10, representing the  $L_p = 40$  mm repair, displays a nearly linear numerical  $P$ - $\delta$  curve up to  $P_m$  (event LP1;  $\delta \approx 4$  mm), which agreed with the average of the experiments. As already discussed, the value of  $P_m$  is related to simultaneous *RL* failures in the wood beam at paths A1 and A2. The repair still sustained loads up to fracture at path A3 (event LP2).

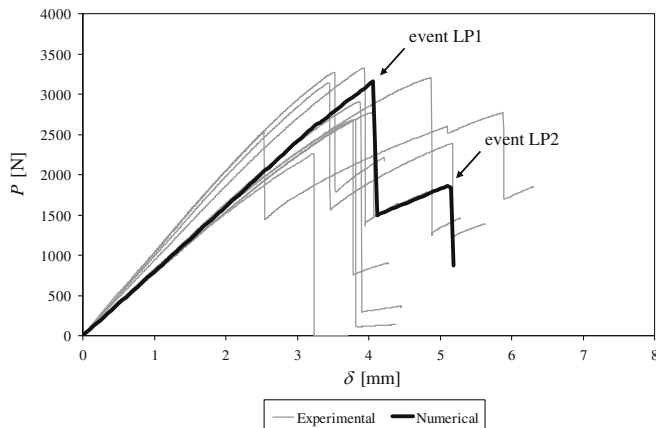
Fig. 10. Experimental and numerical  $P$ - $\delta$  curves for the  $L_p = 40$  mm repair.
