# Influencia da Incorporacao de Particulas de Cortica no Comportamento Mecanico de Laminados Polimericos Reforcados com Fibra de Vidro

# **Influence of Cork Particle Incorporation on the Mechanical Behaviour of Glass Fibre Reinforced Polymer Laminates**

**Dissertation to fulfil the requirements to obtain the Master's degree in  
Mechanical Engineering, with a specialisation in  
Advanced Materials and Manufacturing Technologies**

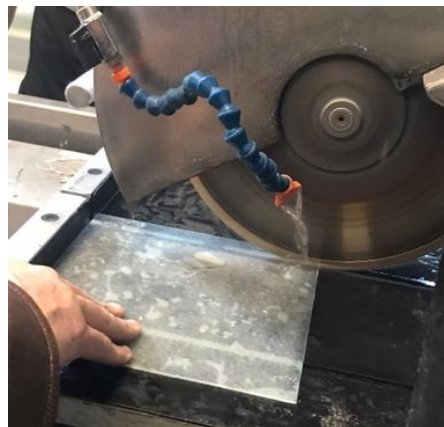
Figure 12 – Cutting process adopted for the preparation of the composite test specimens.

Following the laminate manufacturing process, the composite plates were cut into individual test specimens according to the dimensional requirements of the experimental procedures adopted in this work. The cutting process was performed using a water-jet-assisted cutting system in order to minimise excessive material damage and edge defects during specimen preparation. A representative example of the specimen cutting process is presented in Figure 12.

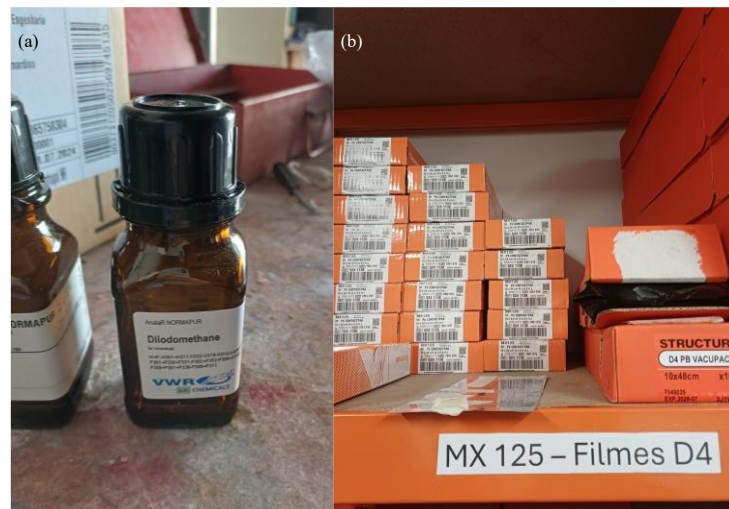
In order to enhance the visibility of internal defects during the imaging procedure, a diiodomethane-based liquid contrast agent, presented in Figure 14(a), was applied to the impacted specimens prior to X-ray exposure. Due to its high density and penetration capability, the contrast agent infiltrates cracks, delaminated regions, and other internal damage zones, thereby improving the distinction between damaged and undamaged areas in the resulting radiographic images.

Following the application of the contrast agent, the specimens were positioned directly over industrial radiographic films for X-ray exposure. MX125 D4 radiographic films, shown in Figure 14(b), were employed throughout the inspection campaign due to their high image quality and suitability for detecting fine internal defects in composite laminates. The films were maintained

Figure 14 – Materials used during the radiographic inspection procedure: (a) diiodomethane contrast agent; (b) MX125 D4 industrial radiographic films.

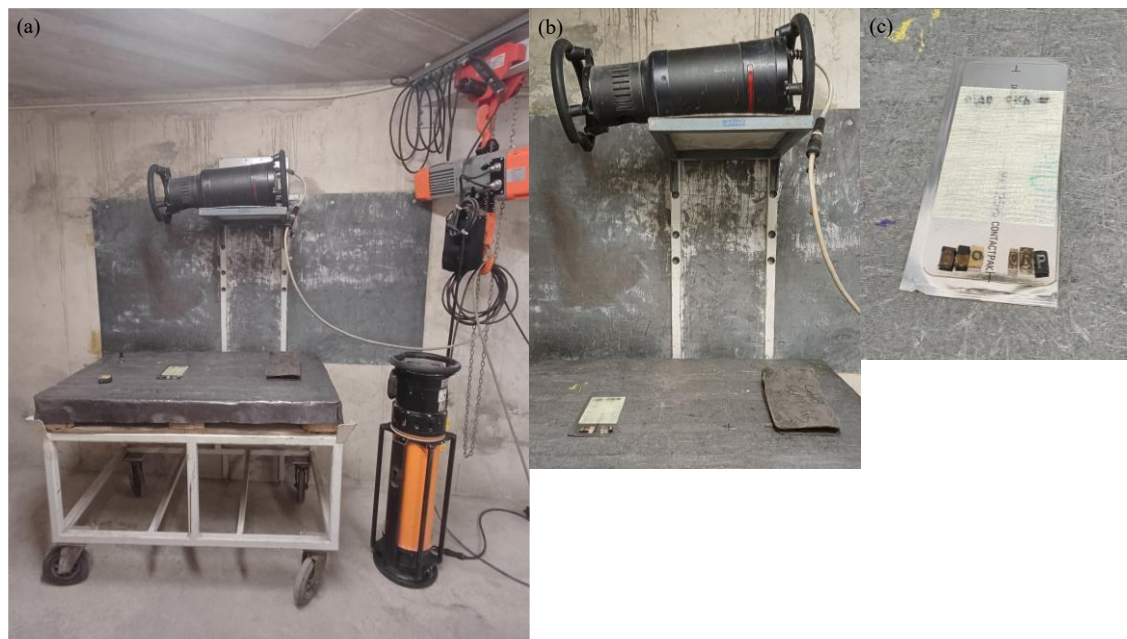
The radiographic inspections were conducted using an industrial X-ray system equipped with a portable X-ray source positioned above the inspection table, with the experimental radiographic setup adopted throughout the inspection campaign, including the X-ray source, specimen positioning, and film arrangement, presented in Figure 15.

Figure 15 – Experimental radiographic inspection setup adopted throughout the inspection campaign: (a) general view of the X-ray inspection system; (b) portable X-ray source used during radiographic exposure; (c) positioning of the impacted specimen over the radiographic film prior to X-ray exposure.

Following parameter optimisation, the impacted specimens were positioned between the X-ray source and the radiographic film under the selected controlled exposure conditions, as illustrated in Figure 15(c) and Figure 16. In order to ensure proper specimen identification and facilitate the subsequent analysis of the radiographic images, lead characters corresponding to the laminate identification codes were positioned together with the specimens during exposure.

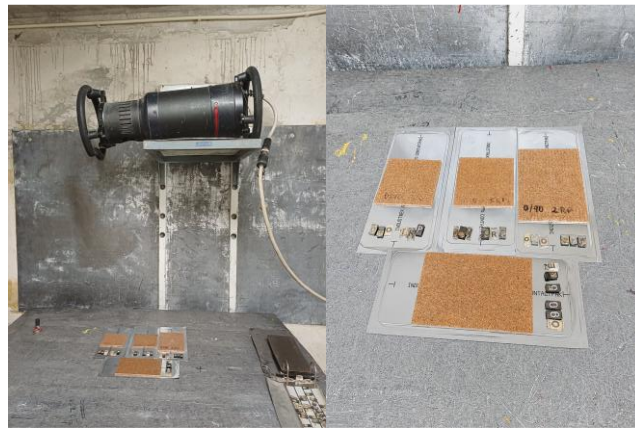
Figure 16 – Setup adopted for the radiographic inspection and specimen positioning prior to X-ray exposure.

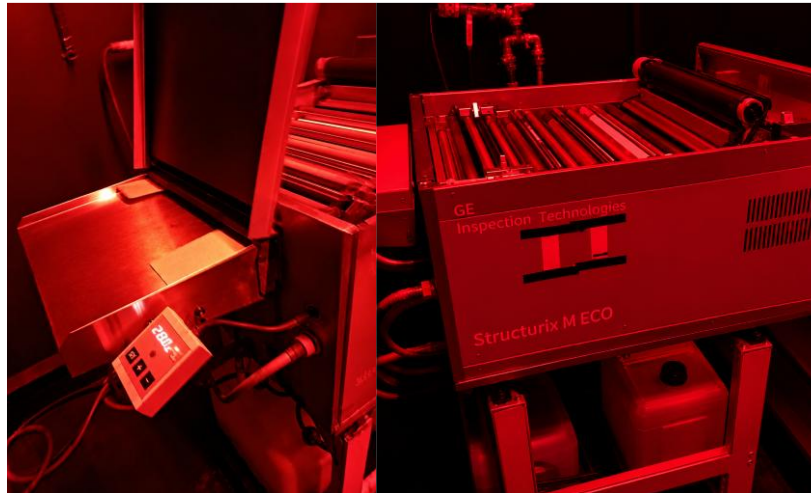
Post-exposure, the radiographic films were processed in a darkroom environment. The chemical procedure involved successive immersion of the films in developing and fixing solutions, followed by washing and drying stages, with the chemical baths maintained at a controlled temperature of 28 °C throughout the operation, in order to obtain the final radiographs suitable for defect evaluation. The film processing workflow and the radiographs obtained during the inspection procedure are illustrated in Figure 17.

Figure 17 – Darkroom radiographic film processing equipment and processing workflow.
