28th International Conference on Flexible Automation and Intelligent Manufacturing
(FAIM2018), June 11-14, 2018, Columbus, OH, USA

Minimizing the Adhesion Effects in Food Packages Forming by the Use of Advanced Coatings

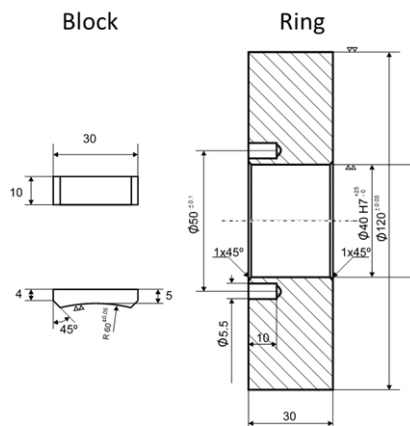
Figure 1 - Rings and blocks samples geometry

In this way, as referred previously, tribological tests were carried out using a block-on-ring configuration. Samples were shaped as blocks and rings, as presented in Figure 1.

Samples assumed two different geometries: blocks and rings. These two geometries performed distinct functions: (a) ring intend to simulate the tool surface while (b) the block intend to simulate tinplate during the contact. Hence, the block was produced with an internal radius of 60.2 mm in order to further accommodate the tinplate sample and keep the stipulated radius in the corresponding value. Tinplate samples with 10 mm x 30 mm were bounded with Loctite 454 structural adhesive on both surfaces. Block-on-ring experiments were performed under dry condition. The normal load and linear speed selected were 70 N and 0.38 m/s, respectively. Concerning to laboratory tests, a load cell was connected to the tribometer arm in order to assess the tangential force induced by the contact between the coated ring surface and the tinplate bonded on block's surface. The signal emitted by the load cell was sent to an electronic device able to filter and magnify this signal converting it in tangential force, expressed in N. Table 1 summarizes all test parameters. This test configuration aimed to evaluate the coating's wear behavior at room temperature, simulating the industrial conditions, as well as, observing possible tin transfer. This test configuration allows as well the friction coefficient determination, coating adhesion to the substrate and pattern wear identification.

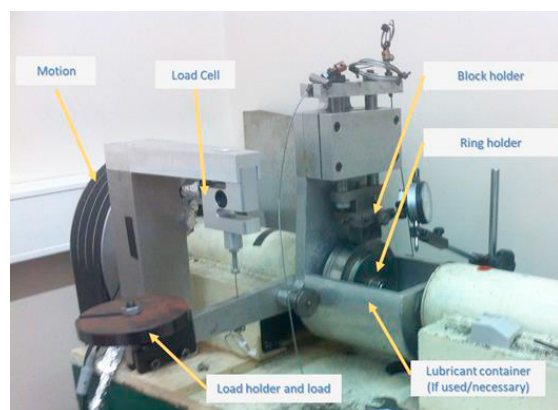
Figure 2 - Block-on-ring configuration view

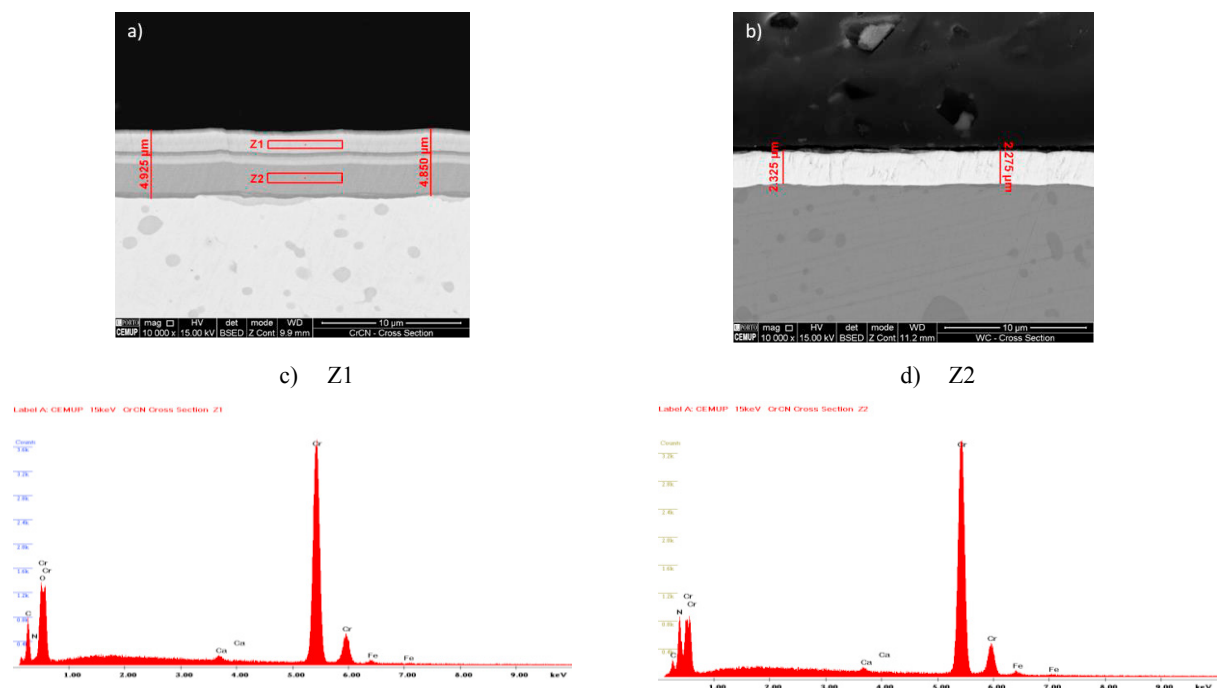
Figure 3 - SEM cross section views of the coatings (a) CrCN and (b) WC, with embedded coating thickness measurements in the figure and (c) CrCN and (d) WC EDS spectra collected during SEM observations

Coatings process resulted in a monolayer thin film for WC (Figure 3 (b)). Regarding the CrCN film, on the other hand it, can be distinguished two distinct layers. Energy Dispersive Spectroscopy (EDS) spectra of the two areas revealed that the inferior layer (Z2) (Figure 3) presents a higher amount of nitrogen (N) relatively to the superior one (Z1) (Figure 3). This is related to a variation of flow in the gas chamber during the deposition process.

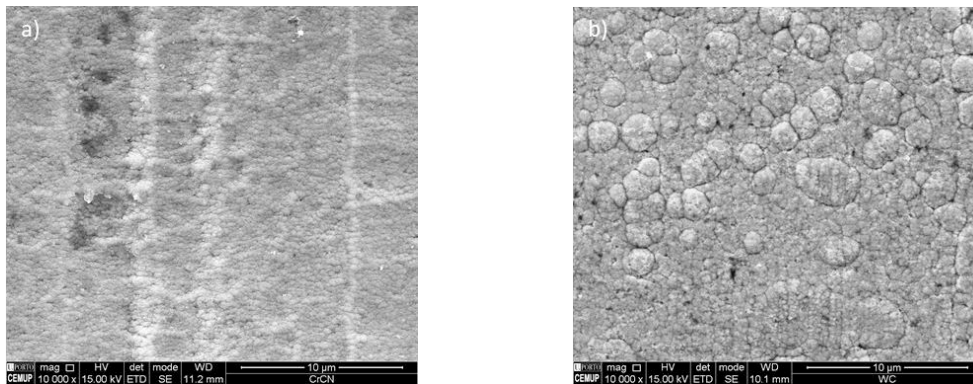
Figure 4 – Coating morphological characterization (a) CrCN and (b) WC (top view)

Films morphology was analyzed by SEM, as previously referred, which can be seen in Figure 4, showing a very textured surface. It is possible to observe that WC has a predominantly large globular structure, whereas, CrCN tends to small globular structure arranged in a columnar form. Hence, CrCN is most suitable for tribological purposes.

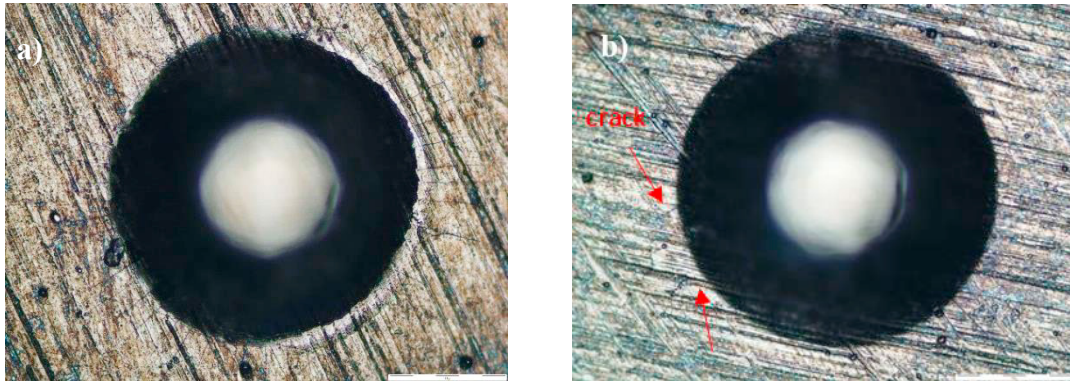
Figure 5 -Optical microscope images of the coating indentations at 150 kgf normal load in: (a) CrCN and (b) WC

The adhesion quality of the coatings to the substrate was also assessed through Rockwell indentations following the VDI 3198:1991 standard [11]. Indentations were carried out at 150 kgf in each coated sample, as can be seen in Figure 5. It is possible to observe a larger number of small cracks in the indentation border of CrCN film than in the WC film. According to the VDI standard, these results can be classified as 'HF1' behavior. No border spallation was verified. The indentation results can be more accurate than the scratch-test, due to the lower influence of the surface roughness, film hardness and coating thickness, as well as the slower increasing of the normal load. Therefore, it can be concluded that both coatings have good adhesion to the substrate.

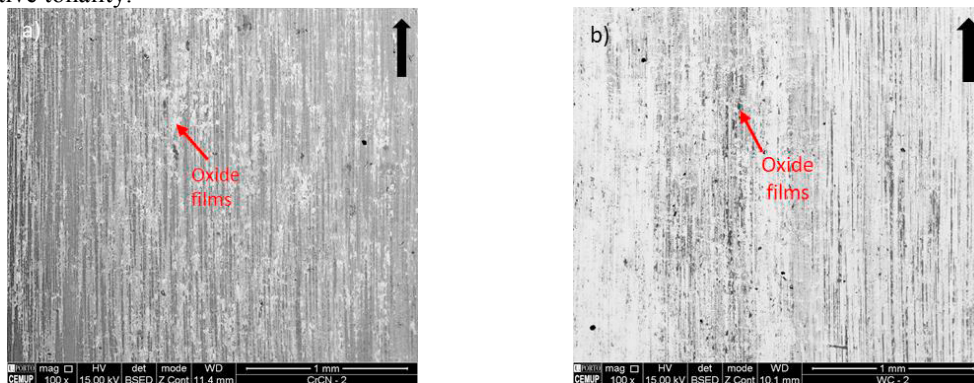
Figure 6 – SEM micrographs on coated ring surface: (a) CrCN and (b) WC. Black arrows indicate sliding direction.

Wear tests were performed in the block on ring tribometer using the entire width of the ring. Figure 6 shows the SEM micrographs of the wear scars corresponding to CrCN and WC coatings after sliding tests. Quantitative evaluation of mass loss was not important to this study, once it was expected mass transfer between surfaces, increasing the weight on the harder surface. Furthermore, tin transfer from tinplate surface to the coated ring was considered more important than weight loss. SEM micrographs reveal no great difference between the two coatings regarding the tin transfer pattern. Indeed, adhesive wear can be observed, as well as, many scratches following the sliding direction. Both coatings present tendency towards to creation and anchoring of oxide films on their surfaces, formed during contact. The oxide films show different shades due to the different density of the coatings, being the shade a relative tonality.

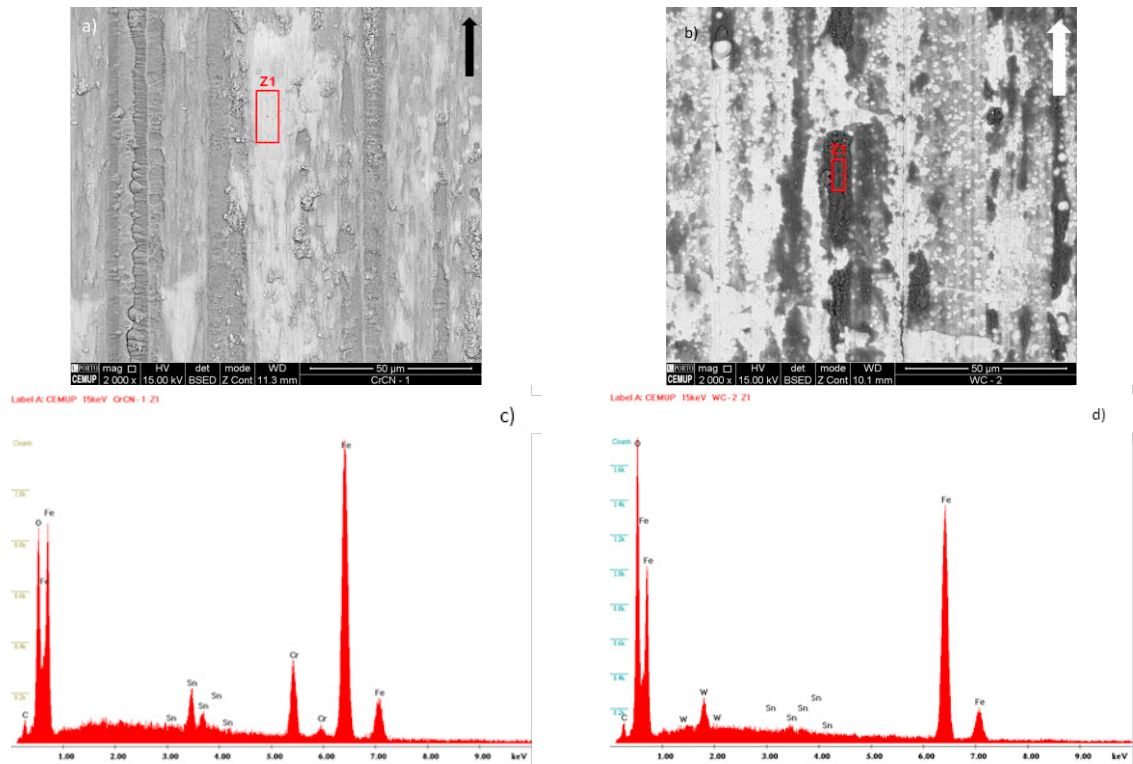
Figure 7 -SEM micrographs and spectra of transferred tin on ring coated surface (a)(c) CrCN and (b)(d) WC.. Arrow indicate sliding direction.

Additionally, the EDS analysis of the wear scars of both coatings are shown in Figure 7. The purpose of conducting the EDS analysis was to detect the type of elements present in both surfaces (coated rings and tinplate bonded to block).

As revealed by the EDS analysis (Figure 7), besides coating particles and oxides, the main elements found on debris layer were iron together with transferred tin, suggesting that steel transfer from the tinplate substrate to the ring surface had occurred.

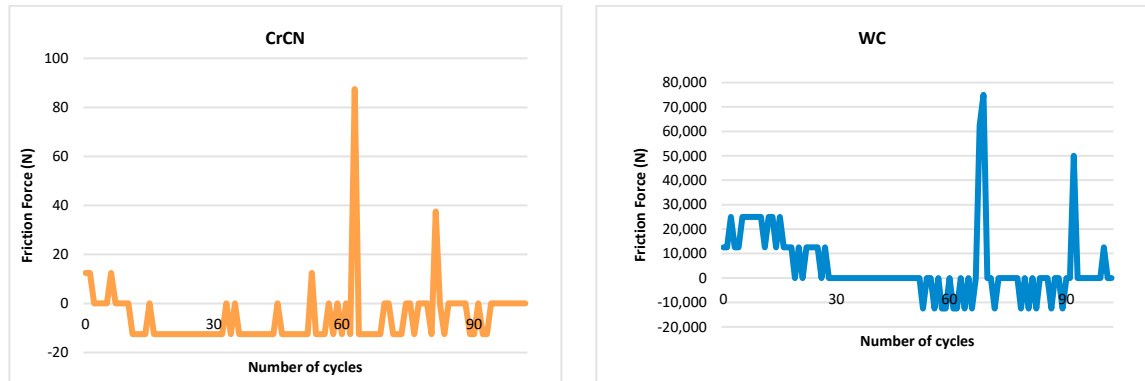
Figure 8 - Variation of the tangential force measured in the block on ring tribometer as function of the number of revolutions made by the coating ring.

Friction force is also very important in this case, regarding the expected application. Thus, frictional force was determined based on the values read by the load cell connected to the tribometer in order to measure the tangential force. Due to the selected magnification and functioning of the data acquisition board model NI DAQ 6036E and the LabView® v7.0 programming software, the values obtained are always multiples of 12.5 N. As can be seen in Figure 8, there is a running-in period where the tangential force is slightly higher for both coatings, but after the initial 30 cycles, the tangential force tends to decrease. CrCN coating has a relatively stable behavior between 10 and 60 cycles, subsequently a stick-slip effect in which tangential force varies between negative values and higher positive values. WC coating also presents behavior from the first 30th cycle onwards, though the tangential force has steeper decreasing trend compared to CrCN. Observed peaks distributed during the test duration, may represent an oxide layer cleavage phenomenon implying a momentary friction decrease. The overall decreasing of the friction coefficient can be connected precisely to the presence of oxide layers formed during the test, which promote the slight decrease of the friction force.
